Future-Ready Steel Infrastructure with Smart Monitoring

How Villari's certified wireless crack detection technology transforms aging steel infrastructure by safely extending asset lifetime and optimizing maintenance.

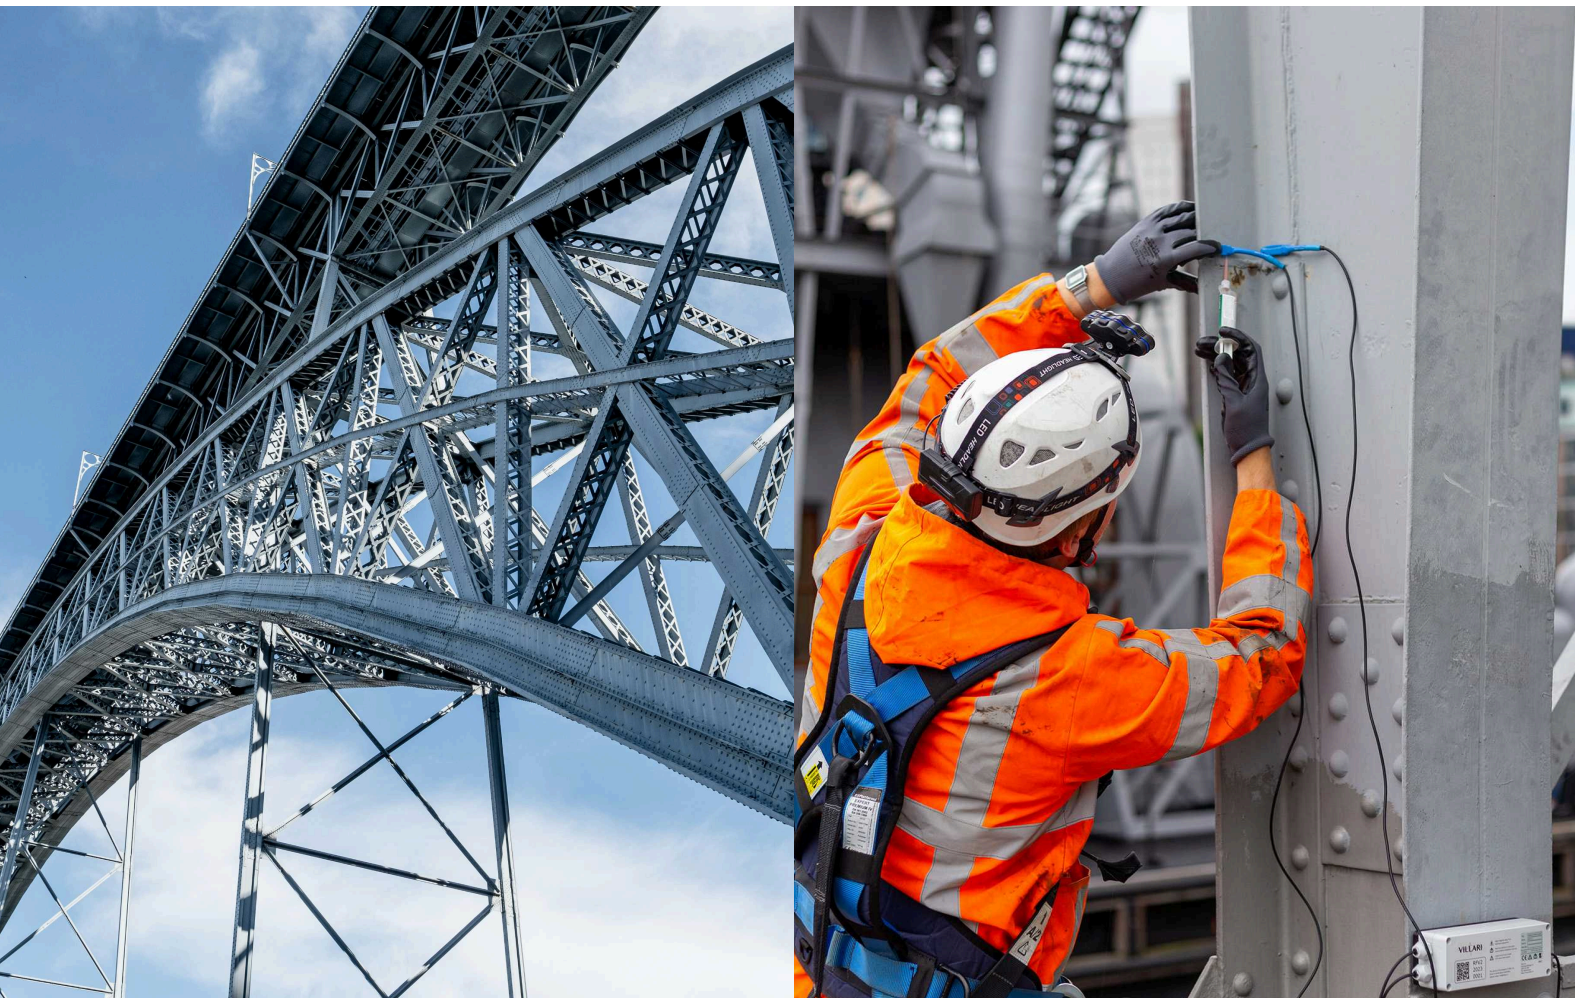
Figure 1 (Left) This image illustrates a steel bridge. (Right) Villari's crack detection sensors are typically installed at critical stress points, to ensure continuous monitoring and proactive maintenance.

To avoid unplanned downtime and expensive repairs, Villari collaborated with the bridge's owner to implement a continuous monitoring system. The sensors were strategically placed on the deformed flange, a process that required minimal installation time and no surface preparation. The sensor system detects crack growth by monitoring changes in the ferro-magnetic field of the steel structure, providing real-time data on any structural developments.

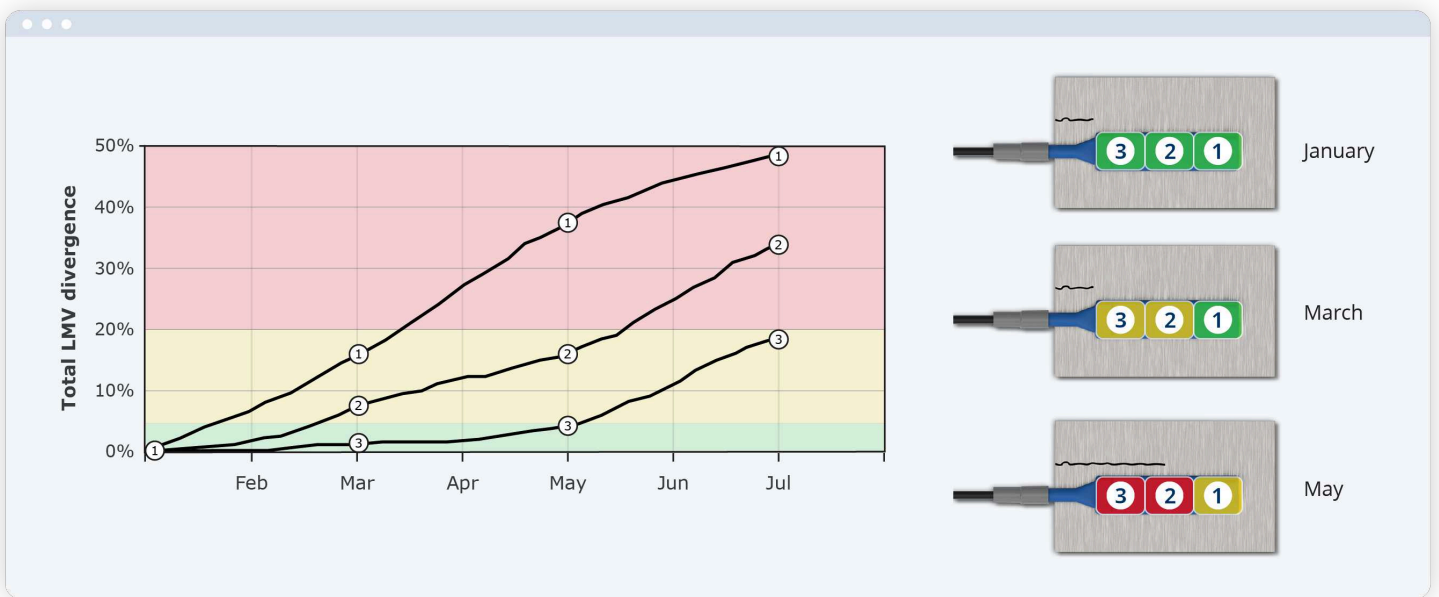
Figure 2 A graph illustrating the key outcomes of Villari’s sensor implementation. The data highlights Villari’s capability of early detecting crack growth and providing unique insights with continuous monitoring.

The implementation of Villari’s sensor system unlocked a new level of data-driven asset management and maintenance. A continuous stream of data provides instant alerts when cracks start to develop. Maintenance costs and downtime were reduced and the EOL for each asset could now be precisely assessed – and increased in 15% –through the valuable data acquired.
