VILLARI | Case Study

A railway bridge in the Netherlands faced a significant challenge after a truck collided with its structure, causing visible deformation to the bottom flange of the main girder—a critical component of the bridge. The deformation raised concerns about potential crack growth and initially a repair was scheduled - but it would result in excessive downtime and substantial expenses, making it a costly solution.

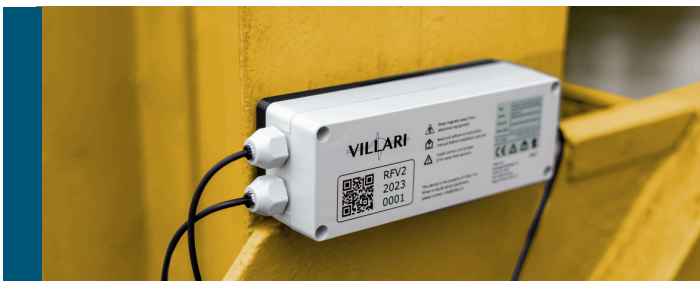
To avoid unplanned downtime and expensive repairs, Villari collaborated with the bridge's owner to implement a continuous monitoring system. The sensors were strategically placed on the deformed flange, a process that required minimal installation time and no surface preparation. The sensor system detects crack growth by monitoring changes in the ferro-magnetic field of the steel structure, providing real-time data on any structural developments.

Since their installation, the sensors have shown no signs of crack growth. This continuous stream of data provided reassurance that the structural integrity of the bridge remains intact despite the visible deformation. As a result, the bridge owner now has the flexibility to reschedule or avoid a repair - with the cost of monitoring negligible compared to the estimated €100,000 repair cost, besides the bridge operational downtime.
